Newport Centre, Kingsway

Phase 1 Geoenvironmental Desk Study

Client: Newport City Council and Coleg Gwent

Project Ref: CC2439

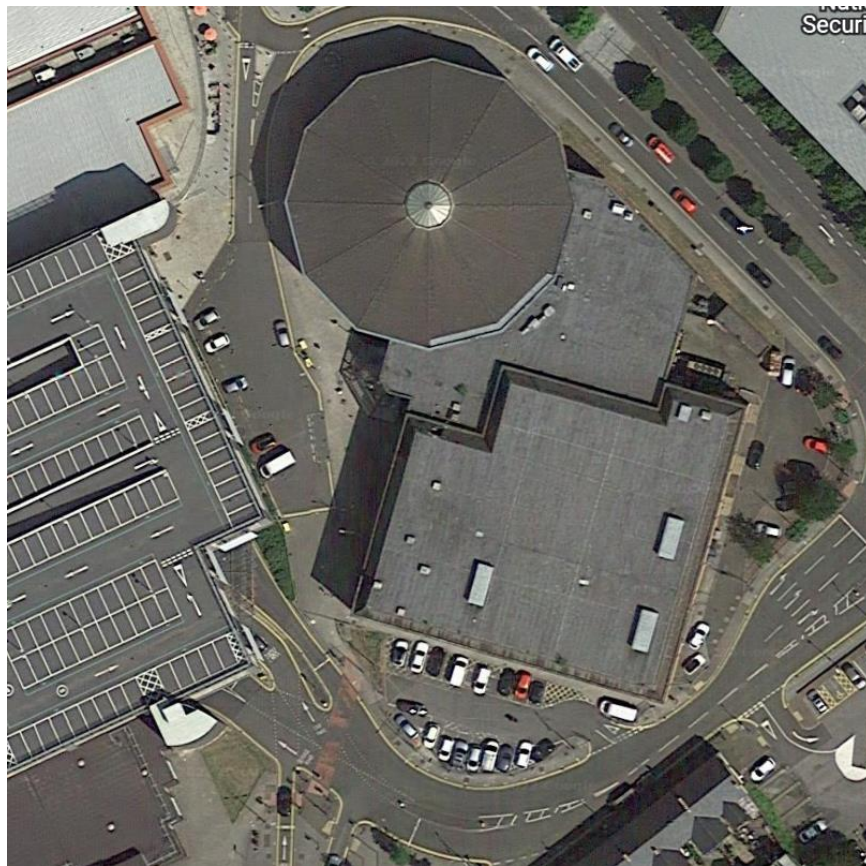
Figure 2 – Aerial View of Site

A general aerial view of the site is presented on Figure 2 below and additional photographs provided in Appendix C

2.3.1 A site walkover survey was undertaken on the 14th of June 2022 as part of this Desk Study compilation. The site is generally indicated to be fully occupied by the existing Newport (Leisure) Centre, areas of parking, access roads and limited hard standing. Very little of the site is unoccupied by the existing use, which we understand to comprise a leisure center, swimming pool, and convention/event facilities. During the walkover a number of structures were identified linked to power/heating the existing building and these included a substation, stored gas bottles and a possible gas governor in the east portion and what appeared to be water treatment/storage tanks and air conditioning units in the south east portion (see photographs in Appendix C).

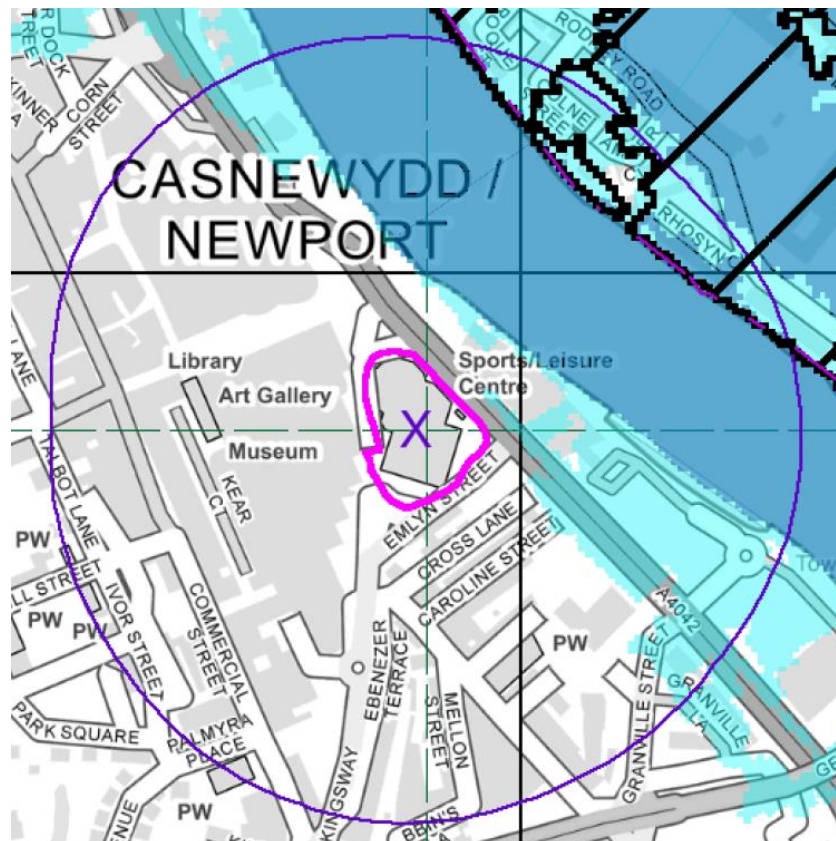
Figure 3 – Risk of Flooding from Rivers and Seas

- 2.7.1 Flooding from Rivers and Seas – Reference to available Natural Resources Wales data and Envirocheck data indicates that the site is not at risk of flooding from rivers or seas, however, the most easterly point of the site is indicated to be adjacent to areas of extreme flooding (see Figure 3). No further assessment of flood risk has been undertaken at this stage but may be required as part of detailed design/planning.
